**ASBESTOS
INSPECTION REPORT**

**SUN LIFE HEALTH
DEMOLITION PROJECT
23 SOUTH MCNAB PARKWAY
SAN MANUEL, ARIZONA 85631**

Dominion Project Number: AZ2510.01

Limited Asbestos Inspection Date: June 25, 2025
Report Date: July 2, 2025

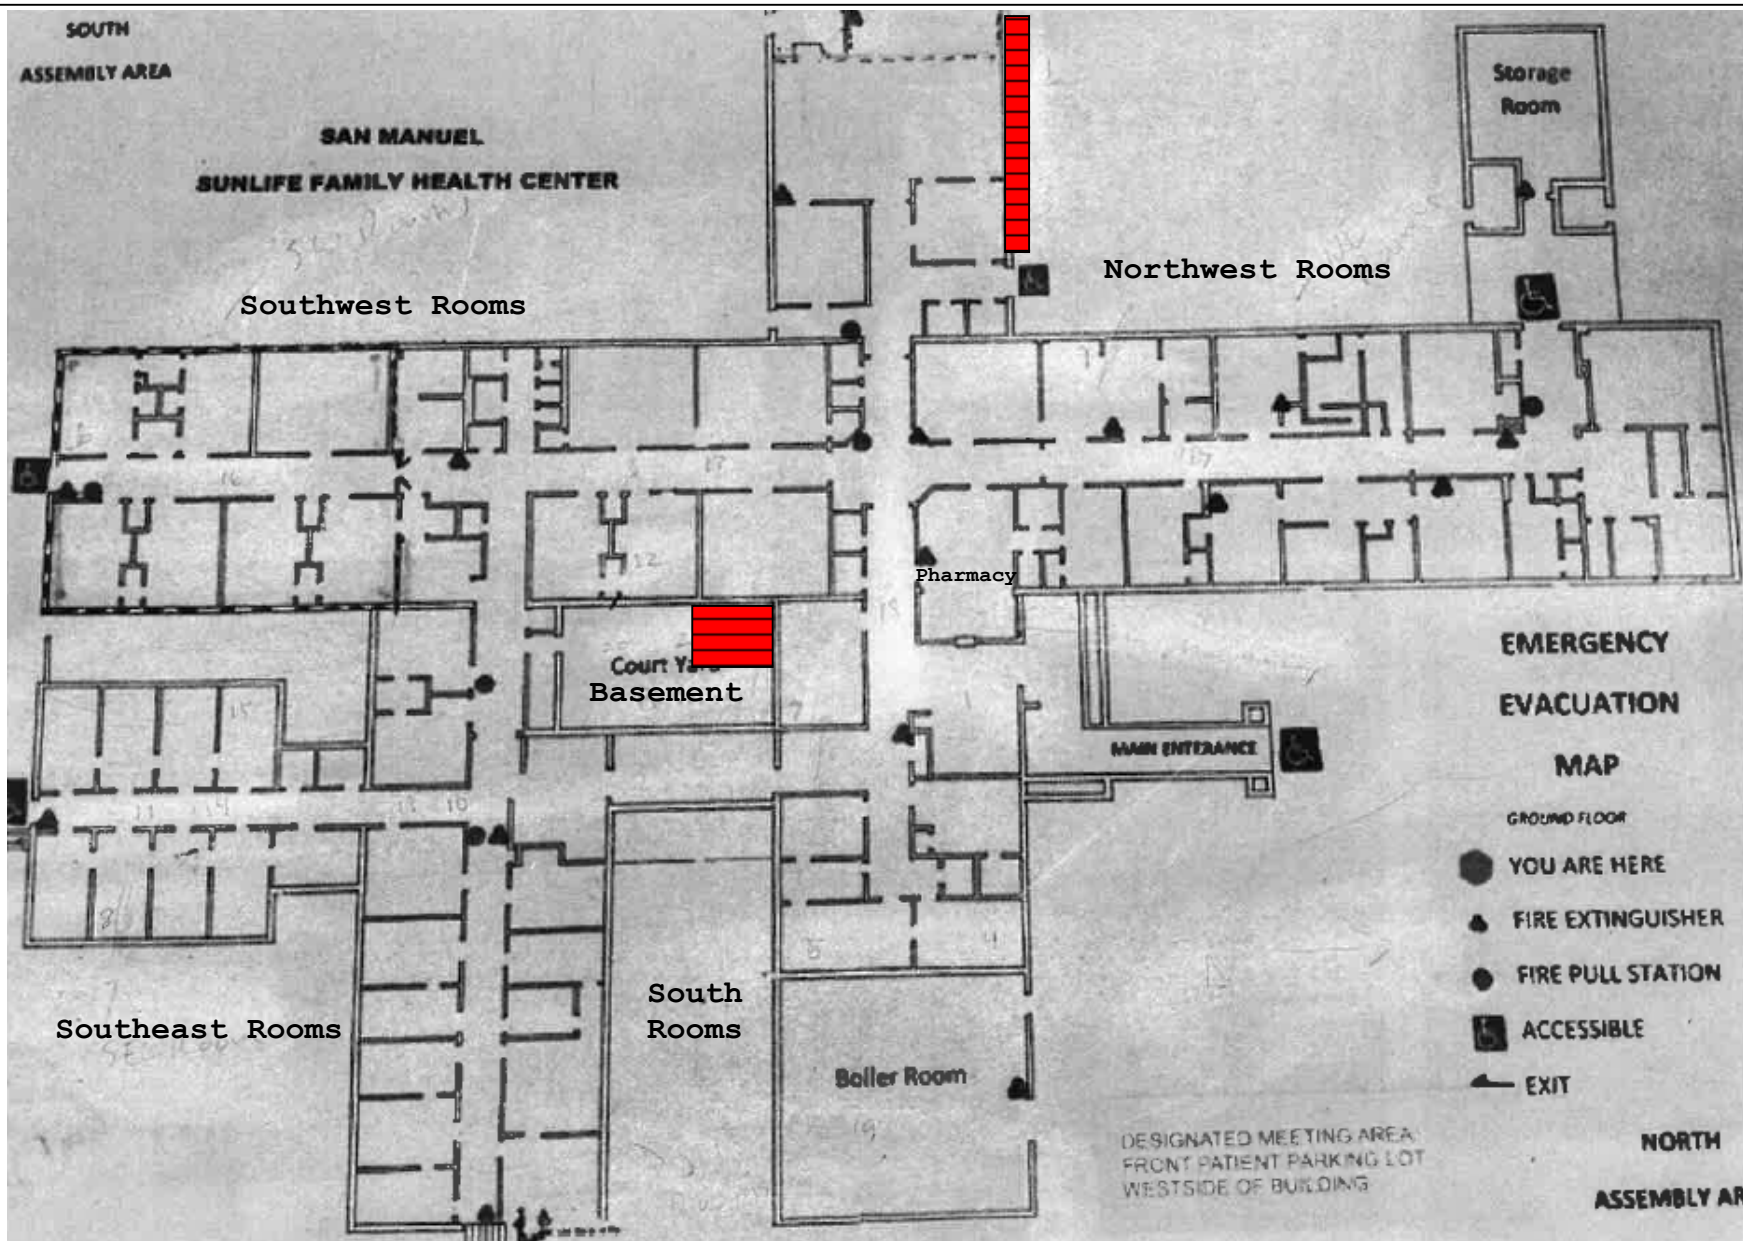
ASBESTOS CONTAINING MATERIAL
LOCATION MAP

Asbestos-Containing
Gray Transite Pipe

Dominion recommends that the above referenced asbestos-containing materials containing greater than one percent asbestos content be removed by a qualified asbestos abatement contractor if any of these materials are scheduled to be disturbed at any time. The contractor should comply with all governing regulatory agencies having jurisdiction over asbestos removal projects.
